INVESTIGATION OF  
THE PREPAREDNESS PROGRAM

REPORT BY  
PREPAREDNESS INVESTIGATING  
SUBCOMMITTEE  
OF THE  
COMMITTEE ON ARMED SERVICES  
UNITED STATES SENATE

THE COLLAPSE OF TEXAS TOWER NO. 4

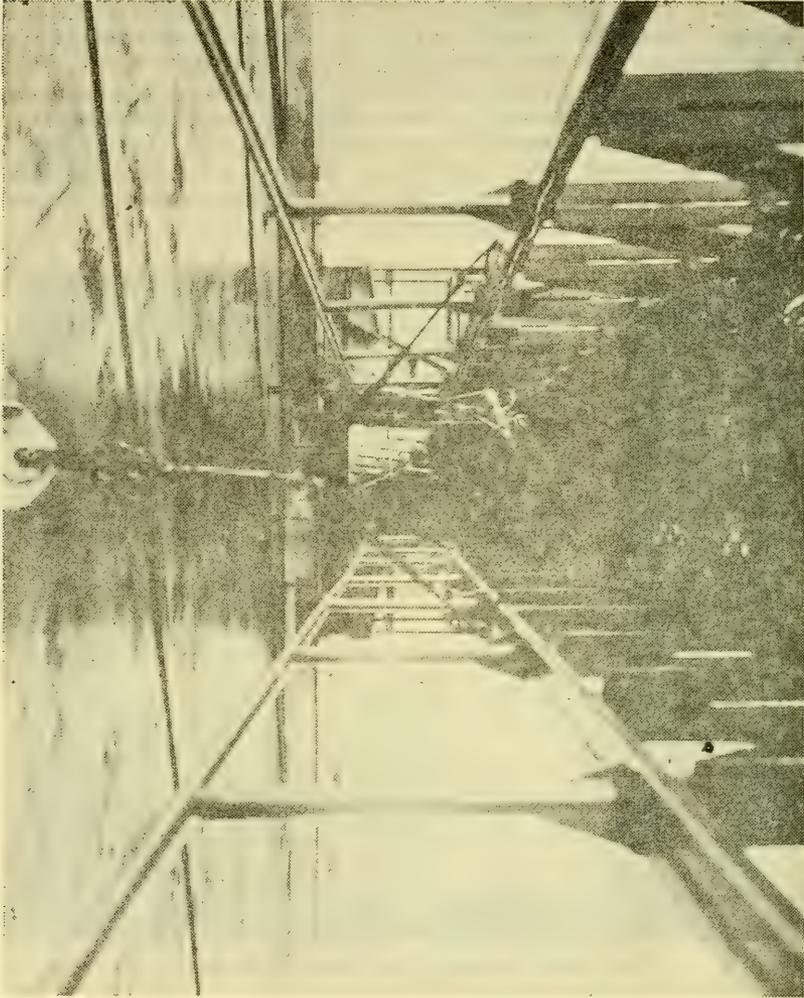
The "flying bridge" or rotating maintenance scaffold suspended beneath the tower had been torn loose and had to be repaired before divers could ascertain the damage to the underwater foundation. For graphic portrayal of damage to the "flying bridge," a photograph showing it against the C leg is reproduced.

Damage to the "Flying Bridge"

J. Rich Steers, Inc., the original builders under contract with the Air Force, completed repair to the "flying bridge" on November 1, 1960, and subsequent inspections revealed the following damage:

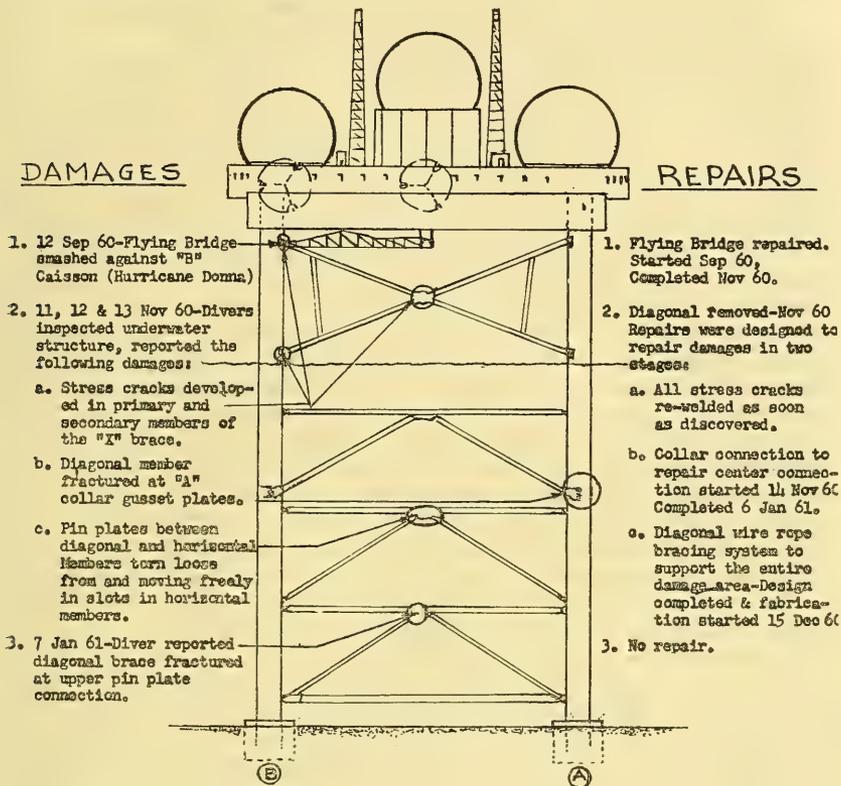
TEXAS TOWER No. 4  
HISTORY OF DAMAGES AND REPAIRS  
12 SEP 60 TO 7 JAN 61

(a) The above-water X bracing was cracked and fractured in its primary and secondary members.

(b) The upper tier A diagonal was fractured.

(c) The two diagonals in the second tier of bracing at the midpoint of the horizontal at elevation -75 feet had torn loose from their attachment and were moving freely. These damages were all on the A-B side.

There is reproduced below a schematic diagram illustrating this damage with the exception that at this time the lowest diagonal brace, shown as being fractured, actually was intact.

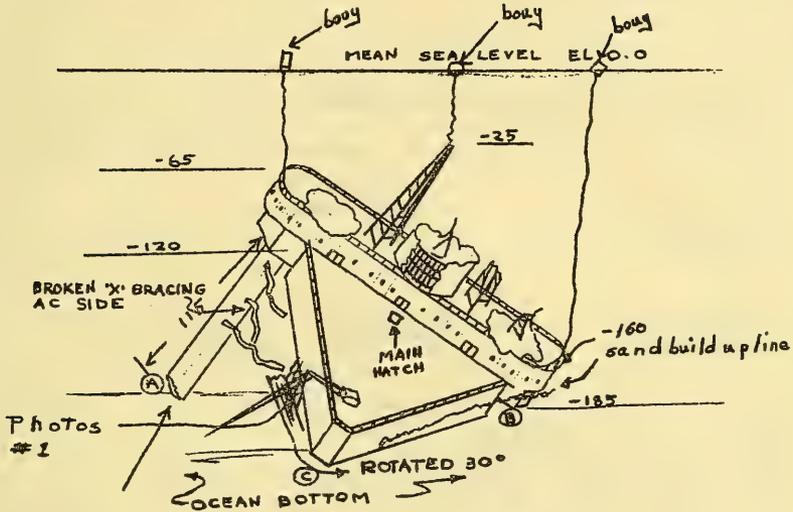
**TEXAS TOWER #4**  
 CONFIGURATION OF WRECKAGE  
 AS INDICATED BY DIVERS  
 REPORTS AS OF 28 JAN 61  
 ISOMETRIC VIEW FROM 'C' CORNER  
 (LOOKING WEST)

length of remaining section of (A) Computed to be 115'  
 upper deck railing carried away  
 all windows fractured or broken out  
 all hatches and doors carried away  
 center radome shell 50% carried away  
 center radar antennae down on main  
 deck hatch  
 2 modulators nearly intact  
 BC side wire safety net carried  
 away

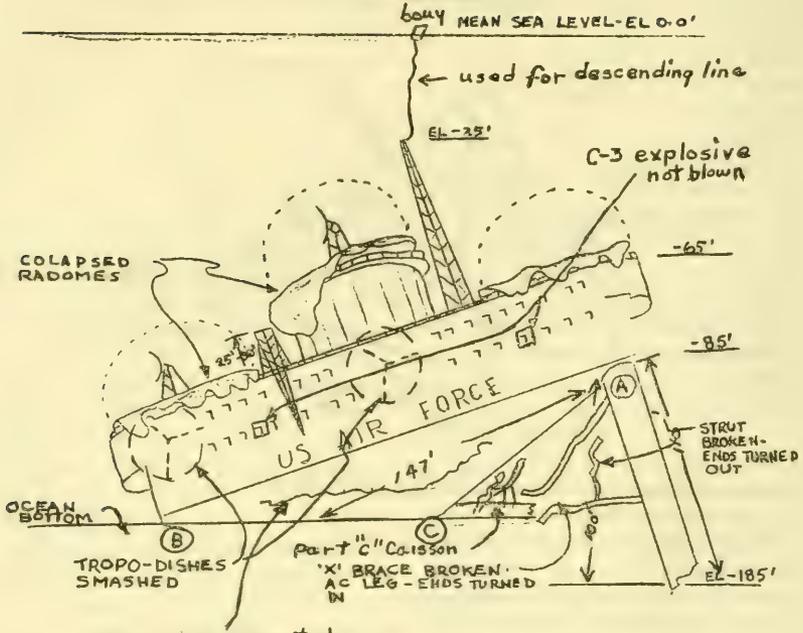
TEXAS TOWER #4

area not inspected  
 Must be additional sections caissons and bracing underneath Tower, assisting "A" caisson in holding platform off bottom,
